Final Evaluation of the Bonaire Sewerage and Sanitation Project FED/2007/19113

Final Report

19/06/2015 Prepared by: Victor HRUSKA & Jan SPIT

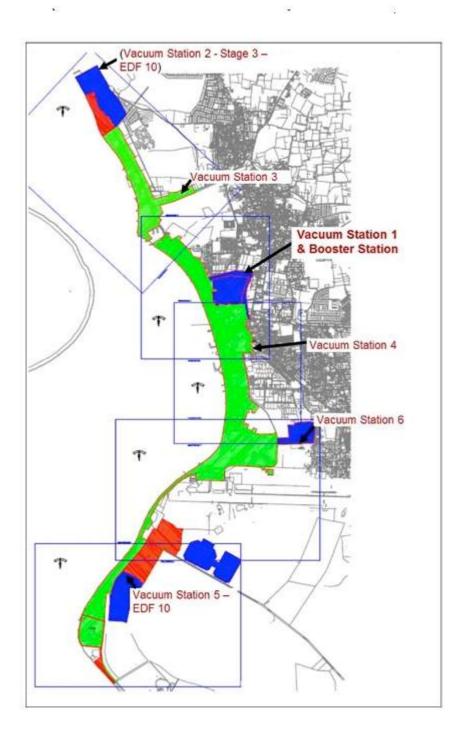
Figure 1 Areas to be connected (Source: Hydroplan)

wastewater infiltration from residential properties and hotels. Other factors are climate change/ increase of seawater temperature that leads to coral bleaching, runoff from storm water, brine from salt works, etc. To limit the wastewater infiltration, it was decided to connect the houses and hotels to a vacuum sewer system, which conveys the wastewater to a treatment facility. The facility is to reduce the pollutants, especially Nitrogen, which contributes to the increase of algae in the coastal area. As water is scarce on Bonaire, the treated water (with a limited content of Nitrogen) is to be used for irrigation of the hotel premises. As the treated effluent should have a Nitrogen content of less than 5 mg/l N, use of this water for irrigation in the sensitive zone along the coast is expected to be without risk to the coral reef. The layout of the system is presented in Figure 1 and Figure 2 and Appendix G.

It must be noted that there are many other factors that influence the quality of the coral in a negative way: the southern locations shown in Figure 1 are probably affected by the salt pans (IMARES monitoring report, 2014).

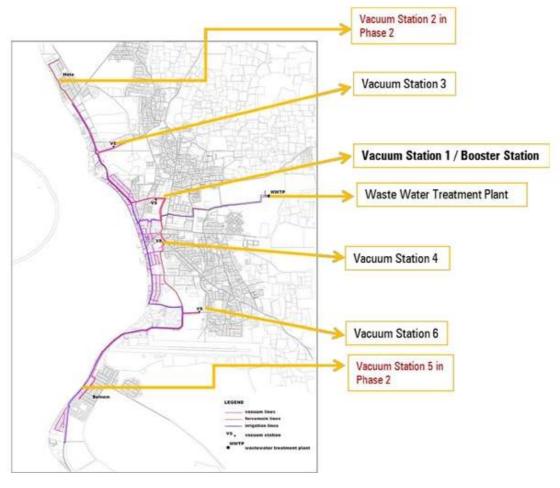
Figure 2: Overview network and components (Source: Hydroplan)

The project has financed the implementation of a sewer system using vacuum technology and the construction of a wastewater treatment plant on Bonaire using the SBR technology. As a complementary measure, house connections from 818 private houses and connections of 78 commercial units have been financed. As not all valves to the system have been opened yet, at the moment, wastewater from 801 private connections and 63 commercial units is treated in the wastewater treatment plant.

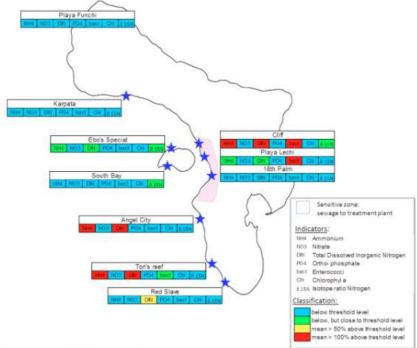
Figure 3: Results field monitoring 2011-2013

As the evaluators are not coral reef experts, they consulted the biologist of the Stinapa⁴ and consulted monitoring reports on the Stinapa Internet site. From this, the evaluators learn that Bonaire has a long tradition of monitoring the quality of the coral reefs. Compared to other islands in the region, the coral reef is in relatively good condition. However, there is definitely a negative impact from the leaching of untreated/partially treated wastewater into the sea. At southern and urban locations (Kralendijk), threshold levels of Nitrogen are exceeded. Chlorophyll-a shows an increase in time and Phosphorus seems to show a similar trend. These eutrophication indicators are likely to exceed threshold levels in near future if the observed trend continues⁵. Figure 3 shows the results of monitoring by the Institute for Marine Resources & Ecosystem Studies (IMARES).

(Source: Water quality of the coastal zone of Bonaire, from Stinapa site accessed 25 April 2015).
