# Testing and developing of desludging units for emptying pit latrines and septic tanks

Results of nine months field-testing in Blantyre - Malawi

Emergency Sanitation  
Project

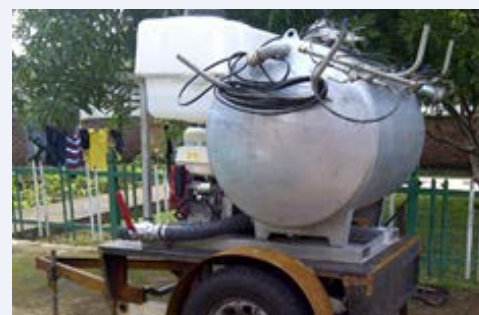
Fig 1: ROM 2.

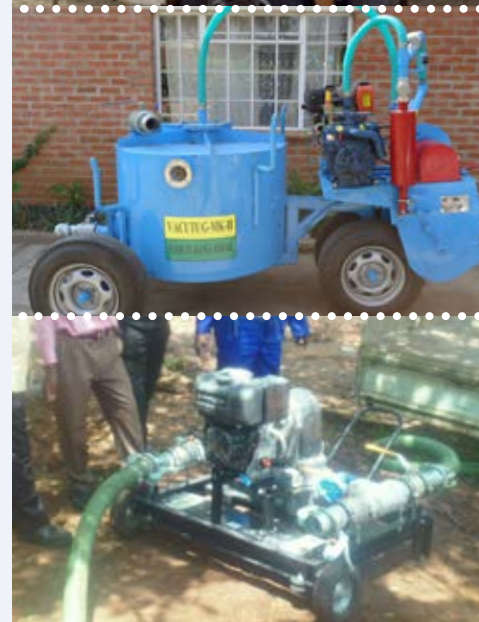
Fig 2: Vacutug Mk2.

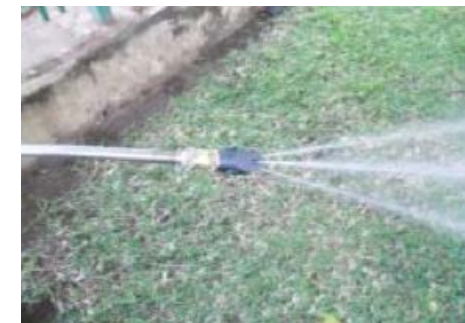
Figure 1: Spray pattern using a 4 jet nozzle at 100 bar.

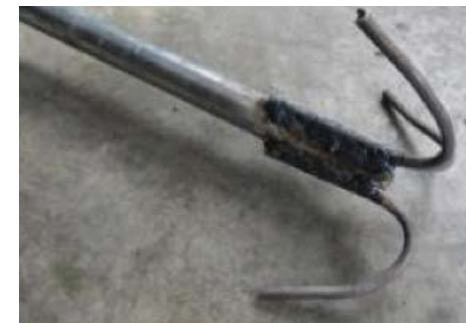
Figure 3: Fishing tool.

Fishing of rubbish is one of the most important steps to ensure efficient removal of sludge from a pit latrine or septic tank. It is also the most unpleasant and hazardous part of the operation, but until different pump technologies are developed, or households refrain from disposing of garbage in pits, it will remain a necessary operation. The amount and type of rubbish found in a pit must be seen to be believed. Out of 54 pits we fished 2840 litres of rubbish, which averages about 50 litres per pit (see Annex C). Fishing is time consuming, taking on average 30 minutes per pit, sometimes more. The fishing tool is a 1.6 m to 1.8 m, 12mm GI pipe with 3 x 6mm grapples welded to it. See Figure 3.

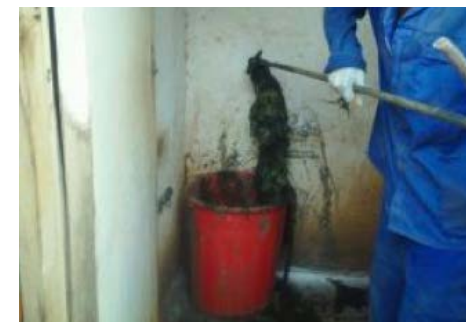
Figure 4: Items fished out include plastic bags and cloth rags used for menstrual hygiene.

The rubbish consists mainly plastic bags and cloths (including menstrual cloths and pads and increasingly disposable baby nappies) and these easily block the suction pipe if not removed beforehand. Shoes, sticks, maize cobs, stones, plastic bottles and charcoal have also been found. The team became very proficient in fishing and with time experienced

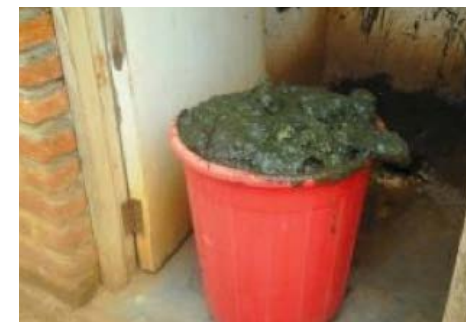
Figure 5: Per latrine 50-100 litres of rubbish is fished out. This takes more than 30 minutes.

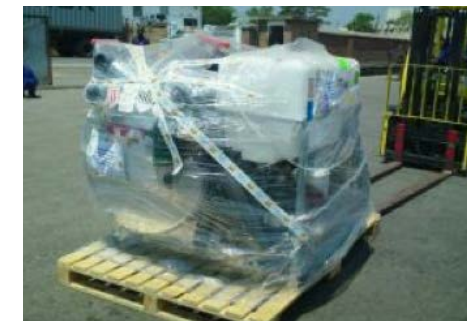
Figure 11: The ROM2 was shipped on a standard pallet.

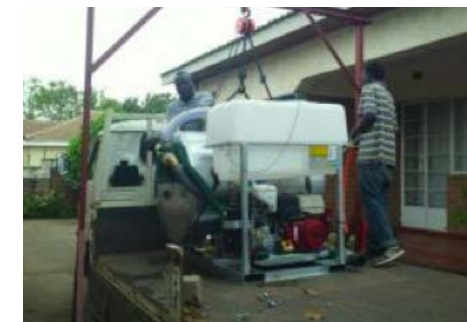
Figure 12: The ROM2 was easily deployed but required lifting gear.

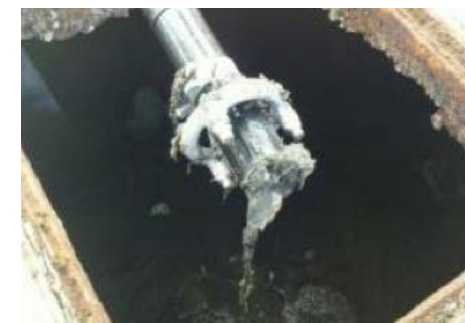
*Figure 15: The 2" kit was blocked even with septic tank sludge as menstrual management materials are often flushed down the toilets.*

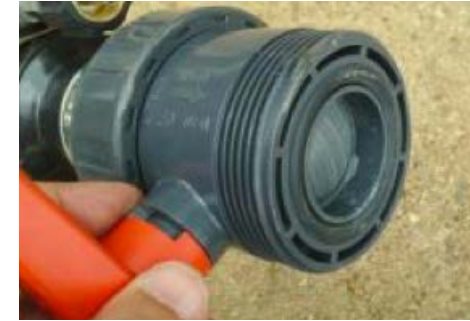
*Figure 16: The plastic ball valve showed signs of abrasion after only a few operations and the threads were easily crossed by operators.*

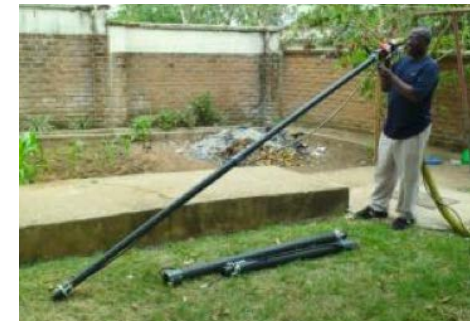
*Figure 17: The 2" lance is far too long to be used in normal pit latrines.*

One of the main challenges we faced was the setup of the suction pipe that came with the ROM2. Table 4 provides a list of the issues, with the recommended solutions. One of the main problems was the operation of the lance. The lance is too heavy and too cumbersome the use. There are too many operations: apart from ROM2 operating the emptying the operator has to control the valve for the pressure washer and the valve for the suction pipe. We removed the valve and the fluidiser at the suction side. For smaller toilets the lance has to be assembled in the toilet otherwise it cannot enter the drop hole. See Figures 19 and 20.

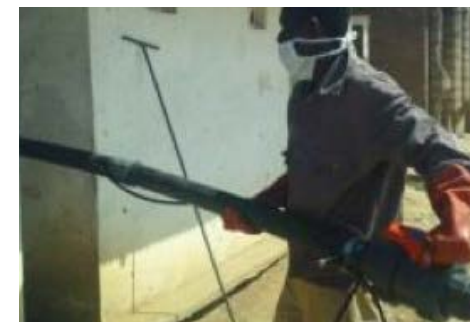
*Figure 18: Due to the small doors, the lance and the suction pipe had to be assembled inside the toilet.*

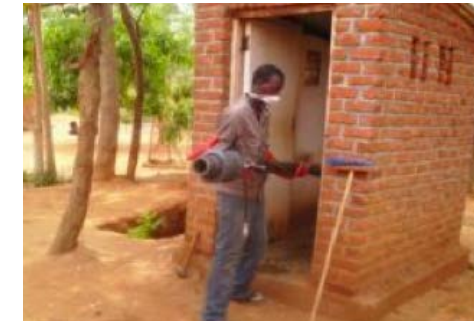
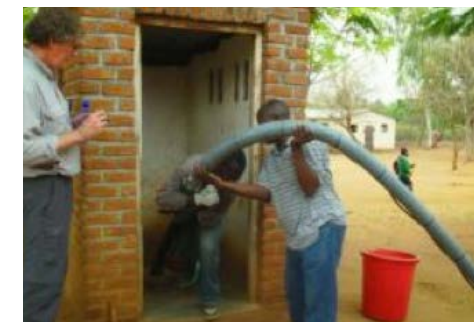
Figure 19: Cumbersome lance.

Figure 20: Cumbersome lance.

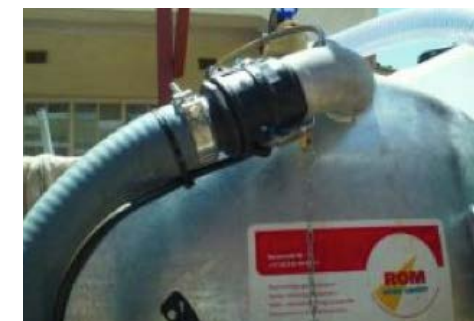
Figure 21: The plastic clamps were not durable and we experienced air leaks.

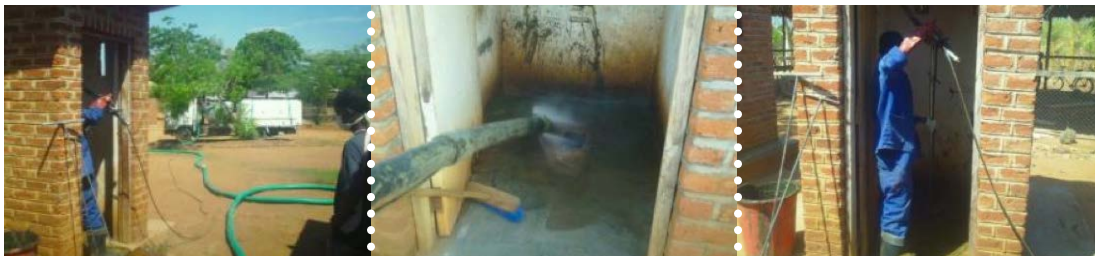
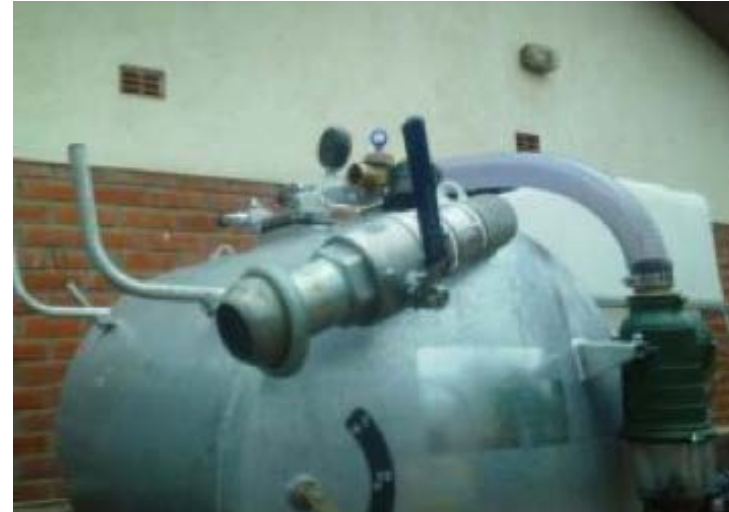
Figure 22: We changed to a metal and have observed they are more durable and have no air leaks. We changed the suction valve from plastic to metal. It is easier for the truck side operator to control the suction valve. The elbow somehow restricts the flow of the thick sludge.

We adapted the discharge by fitting a clamp fitting and a 15m suction pipe (3").

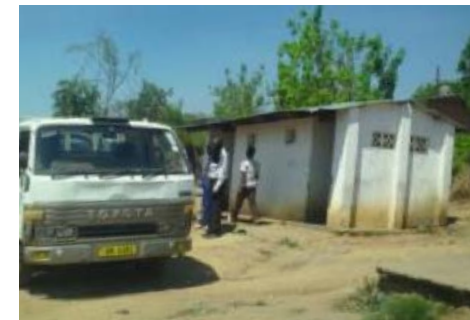
Figure 25: The original length of 3" suction pipe supplied is 15m, and is too short to access many toilets.

As outlined in our report, in order to access as many toilets as possible it is recommended that the suction pipes be of 3" diameter and 30m length. For ease of handling it is suggested they come in 2 lengths of 15m.

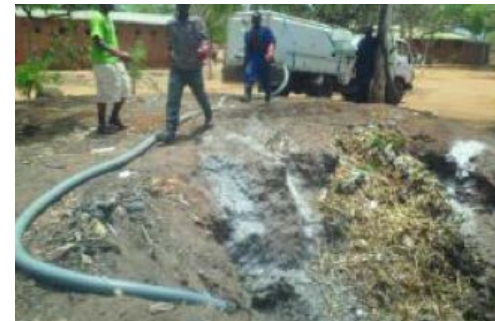
Figure 30: Increased length of discharge pipe – to make it safer and easier to discharge into a sewage disposal or pit.

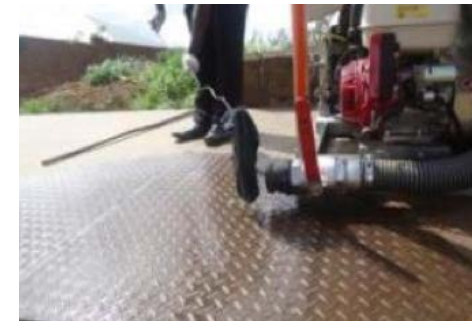
Figure 33: Some of the blockages were easily removed using a wire hook: in this case a pair of panties were removed from the discharge side.

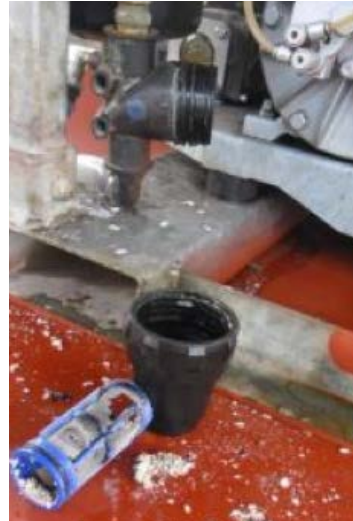
Figure 38: The filter body housing and the filter dismantled. The gauze of the filter has been perforated and there was a lot of sediment found in the filter housing.

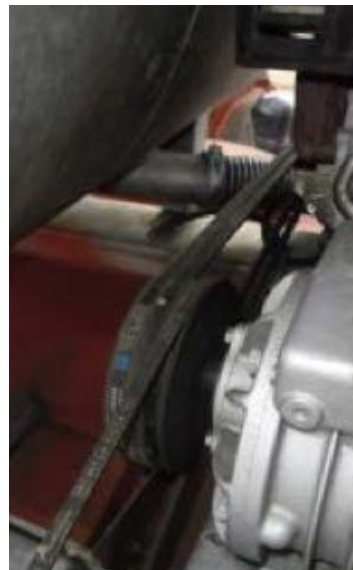
Figure 39: The drive belts broke and were replaced after 300 operations.

2. After 350 uses the **drive belts** for the vacuum pump and pressure pump broke. The 3 belts were readily available locally and cost €12 to replace. In an emergency situation, however they may form part of the spares kit.

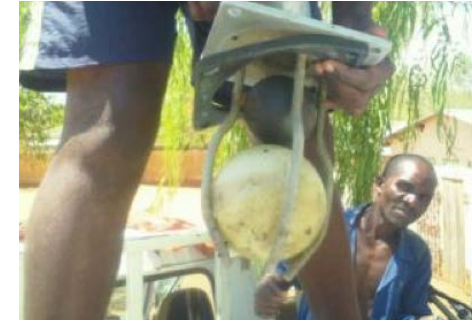
Figure 35: Dismantling top hatch.

In November a serious blockage occurred where even pressurising was ineffective. We removed the inspection cover from the top and fished out several plastic medicine bottles, which were causing blockage with thick sludge such as stones, charcoal, etc. When the top inspection hatch was opened it was observed only one plastic bag, which was jamming the ball valve of the level indicator. This shows that while the fishing process is highly effective there are smaller items that cannot be fished out and will accumulate in the tank. In order to make the cleaning of blockages easier it was recommend to install an inspection hatch /man hole be fabricated on the end of the tank.

See figures 35 and 36.

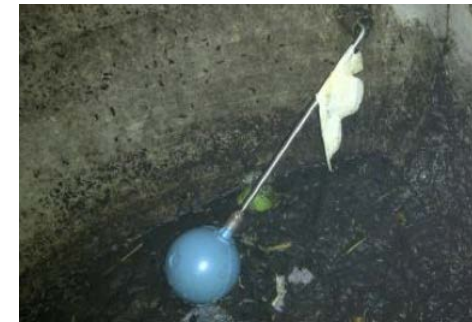
Figure 36: Jammed ball valve.

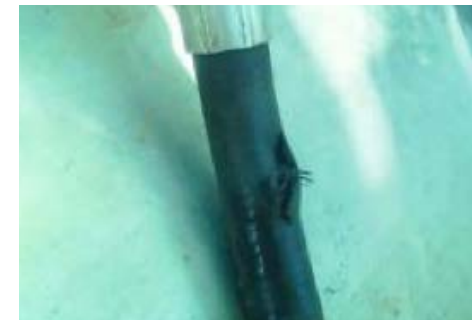
Figure 37: The pressure hose burst – it was seen that the pressure regulator was mistakenly set too high.

1. After more than 280 uses, the **pressure hose** burst. It was found that the pressure relief valve for the pressure pump was set at 120 bar, and it was reset to 50 – 60 bar. A new pressure hose was made using the same connections, just replacing the sleeves and hose. The job took less than 30 minutes by a specialist (Bearing and Machinery) and cost less than Euro100. In emergency situations, such a repair may not be readily available and it is suggested that the regulator is set and sealed to 60 bar to prevent a rupture in the first place and the pressure gauge is always set to be more visible to the operator. It is recommended that the pressure regulator be permanently set to 100 bar.

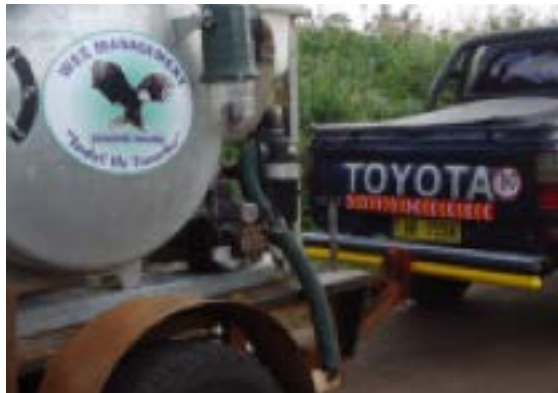
Figure 42: Trailer prototype using either 15" or 16" wheels for compatibility with towing vehicle. The trailer proved very stable on and off road. The 'bakkie' is also convenient for carrying 45m of 3" pipe (30m suction and 15 m delivery) plus equipment like safety clothes, buckets for rubbish, sprayer, fishing tools, etc.

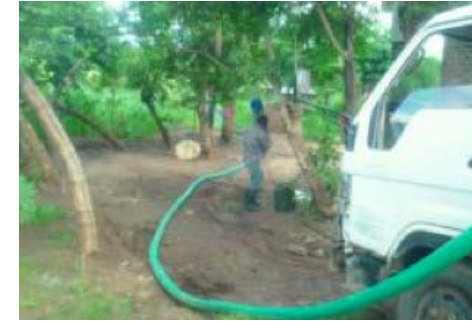
Figure 40: The Toilet is 30 m away – and inaccessible by the truck. Pressure hose to the right of the suction pipe.

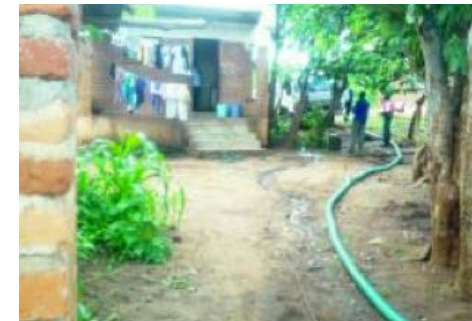
Figure 41: 30 m suction hose with 30 m high pressure hose (to the left) – distance was no problem either for pressurising nor for suction.

- High Pressure hose to be provided at separate reel. 30 m of high pressure hose.
- The end of the High Pressure lance is to be fitted with an ENZ Pointed nozzle, with 4 nozzles angled upfront.
- Secure the unloader to prevent pressures above 100 bars (100 bar to be set as an absolute maximum).

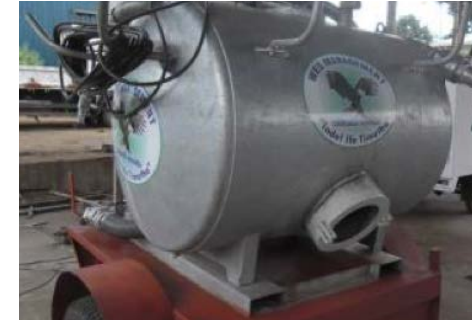
Figure 43: The inspection cover supplied by ROM was welded on by a local welding shop.

The inspection cover was fitted towards the end of March by Mike's Welding, at a cost of approximately €330. We will test this for airtightness and for ease of cleaning the ROM2 tank from blockages affecting the gauge and the discharge on site during operations as well as for general maintenance.

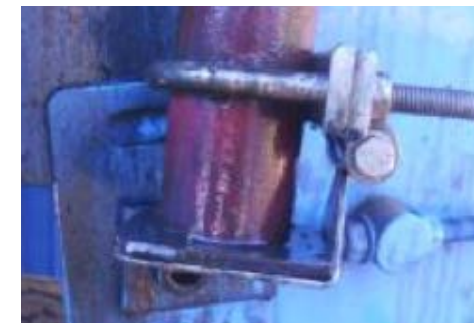
Figure 52: For the pressure chamber to be under vacuum the flap valve should be shut by lifting manually – it will remain sealed to maintain the vacuum.

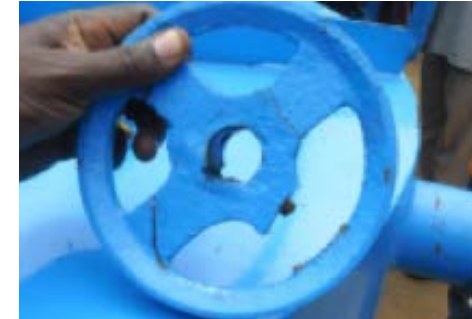
Figure 56: The original Vacutug pulley broke – and we failed a decent repair and could not find an off the shelf replacement.

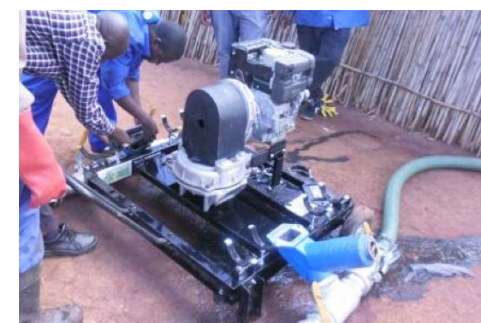
Figure 65: Dismantling, cleaning and reassembly of the 2 ports takes 30 minutes.

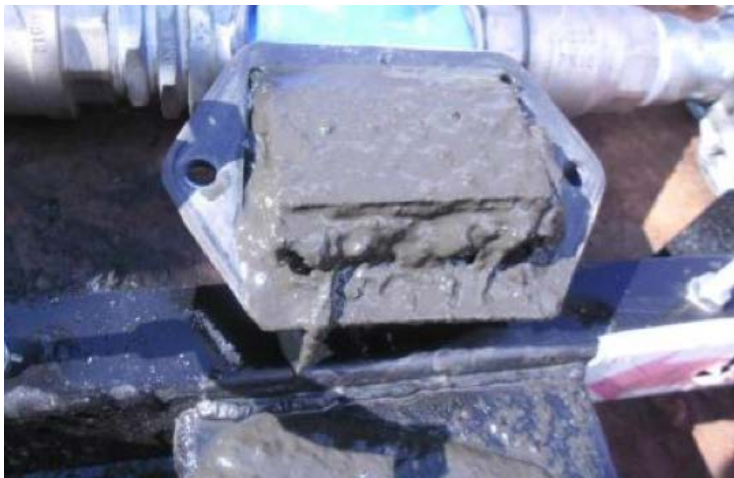
Note: in both pictures, the sludge is quite thick – so the pump has the capacity to pump; the problem is the rubbish in the sludge, which cannot be fished out.

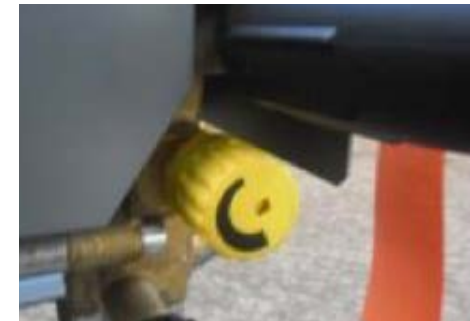
*Figure 70: Details Karcher pressure washer. The pressure of the water jet is regulated by the knob.*

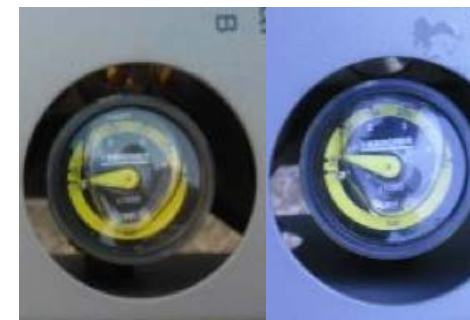
*Figure 71: Details Karcher pressure washer. The pressure gauge is calibrated in 50 bar, 100 bar, 200 bar etc. On the right set to operate at 50 bar.*

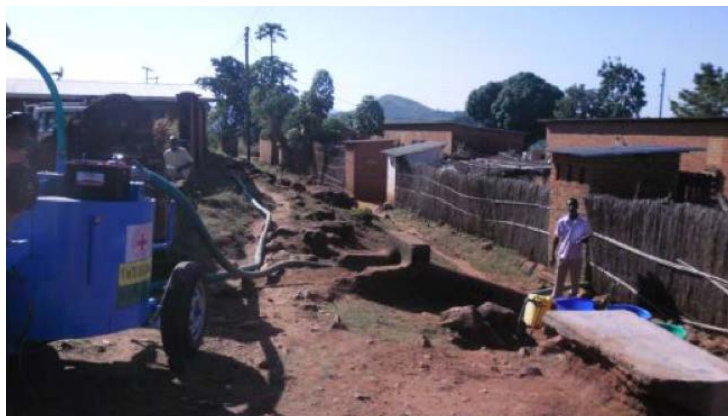
Figure 72: With fluidising the Vacutug was able to access and empty hard toilet sludge from a distance of 30m and an elevation of 2m. The Karcher fluidiser is next to the toilet (white building in the background). Otherwise the toilet would have been inaccessible.

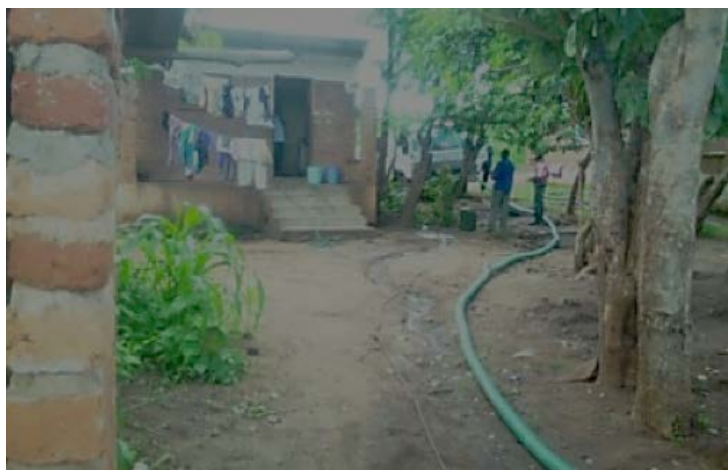
Figure 73: With the ROM2 a 30 m suction hose with 30 m high pressure hose (to the left) and performance was good.

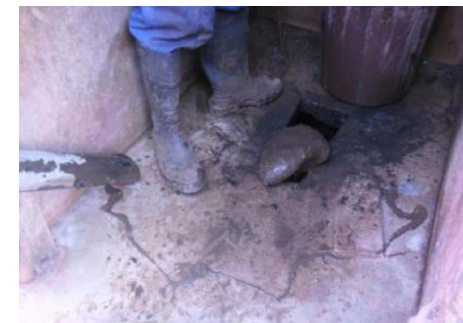
Figure 74: The sludge is often so thick and solid that rocks like this are suspended and are loosened during the fluidising process.

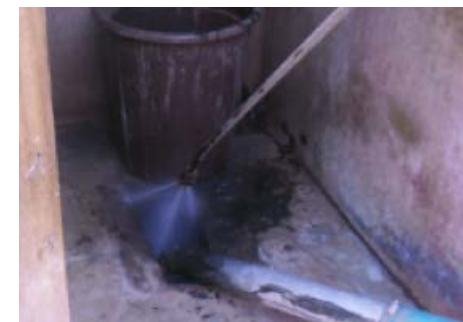
Figure 75: Fluidising is an essential part of pit emptying – including fishing out of rubbish from the now softer sludge and the pumping out the sludge.

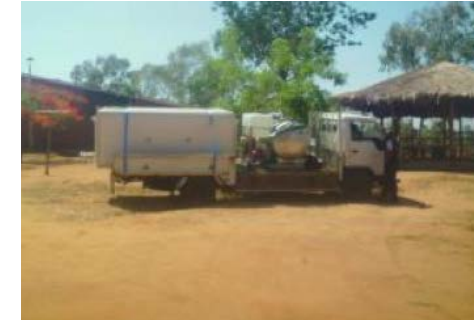
Figure 86: The tank was mounted on a 3 ton lorry, together with the ROM2. However it is advisable to mount the tank and possibly desludging pump in a 7 ton lorry.

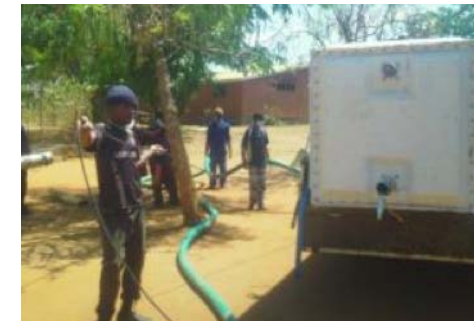
Figure 87: Due to the position of the discharge port, the tank cannot be wcompletely emptied of about 0.5 m<sup>3</sup> sludge.
